ALTERNATOR FIRES IN VEHICLES

BY PAUL W. HANSEN, P.E, EDINA, MINNESOTA—Vehicles built before the 1960s had generators — direct current (D.C.) machines — rather than alternators. Unless the charging system was modernized subsequently, this article does not apply to such vehicles. Generators, in addition to being heavy and expensive, were unreliable by today's standards and required replacing brushes frequently. In addition to this periodic maintenance, it was also necessary to have a relay between the generator and the battery to prevent the battery from discharging through the generator windings when the engine was off. The alternator was a huge step forward for electrical reliability in vehicles. The solid-state rectifier diode made the use of an alternator in a vehicle possible. This advance in alternator technology was pioneered by the Chrysler Corporation in the early 1960s. Other manufacturers quickly followed suit.¹

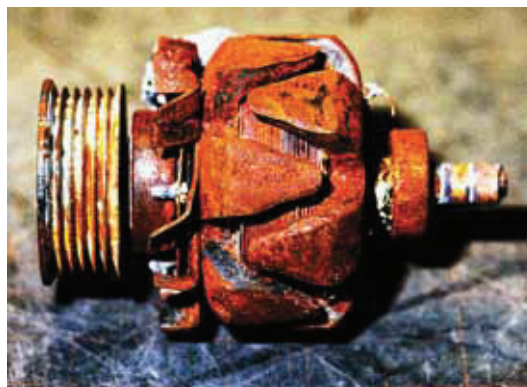
This rotor from a fire-damaged Lundell alternator shows the unique "claw-pole" configuration.

developed the design, and *claw-pole* refers to the unique configuration of the rotor. In recent-model alternators, both the voltage regulator (encapsulated) and the rectifier assembly (six diodes) are in the end cap of the alternator opposite the drive pulley.

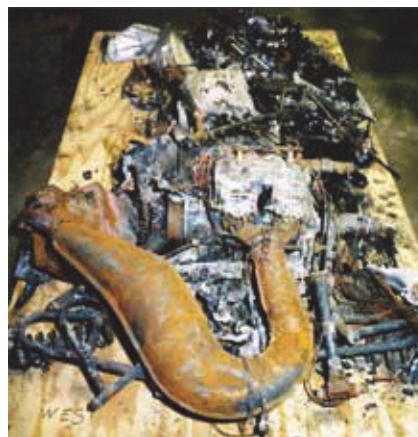
Diodes in the rectifier of this snowmobile alternator failed resulting in a fire causing selective damage to the windings embedded within the engine housing. This type of winding damage is proof of diode failure, but not all diode pair failures will result in this indication or “tell”. Ignition occurred at the charging system cables.

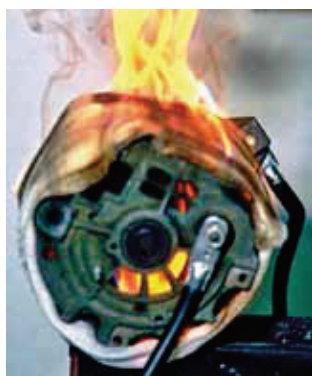
The accompanying photograph demonstrates the viability of shorted battery current through an alternator winding as an ignition source. The experiments were done with a cheesecloth wrap simulating a nearby fuel load, reminiscent of standard U.L. testing. The first test, done by physically hard-wiring a winding to the positive and negative terminals (the post and ground, respectively) resulted in the depicted fire in about 20 minutes.

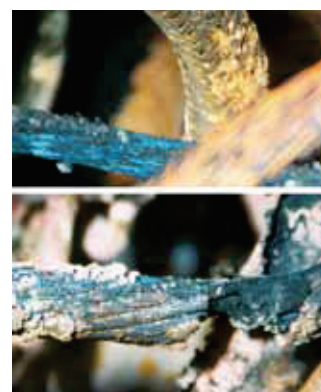
Two views of the cable between the battery and the alternator which was the source of ignition.

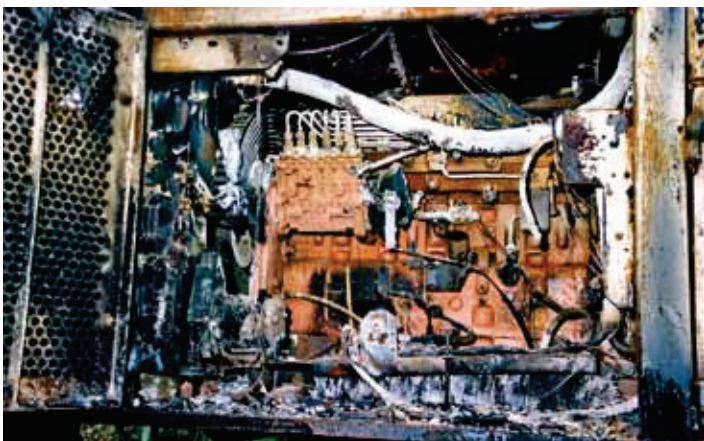
An alternator caused fire in a parked logging machine burned itself out over the night and was discovered the next day.

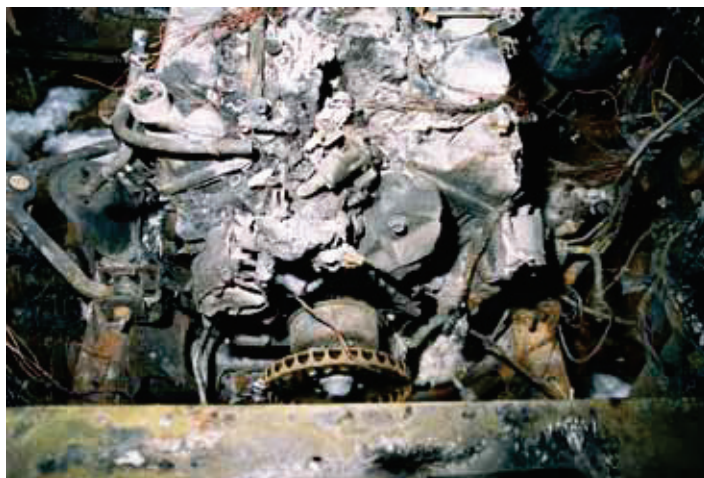
The above alternator, the cause of the engine fire pictured on the right, had actually fallen from its original mounted position on the front of the engine. It was recovered by the fire department.

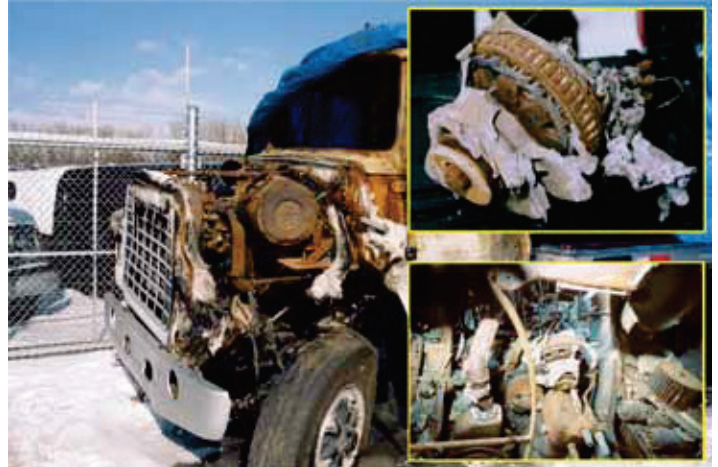
An alternator failure resulted in the engine fire of this truck. The insets show the destroyed engine compartment and alternator.
